## PREMISES DESCRIPTION

Architectural Style..... Multi level frame dwelling  
No. of Kitchens..... 1  
No. of Bedrooms..... 5  
No. of Bathrooms..... 4  
Foundation..... poured concrete & slab-on-grade  
Basement ..... finished  
Crawl Space..... accessible  
Garage..... one-car attached  
Age of Original Premises... 55 years (reported by MLS)

## Findings and Recommendations

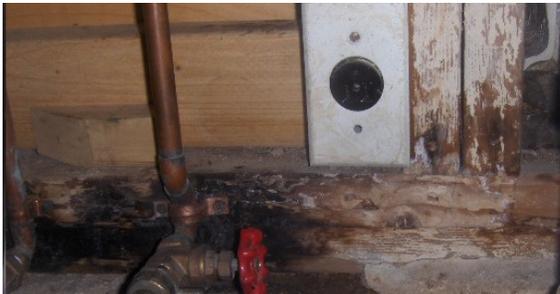
Most of the load bearing components of the house were hidden within finished walls. The visible portions of the load bearing wood framing are located in the crawlspace and the observable sections of the basement. Our inspection of the only unfinished area of the basement is located in the washroom closet. Our survey of this closet revealed termite damage to a sill plate. Since the sill plate is termite damaged it must be replaced to restore the original loading bearing capacity of the wall. Estimated cost is \$1,000.

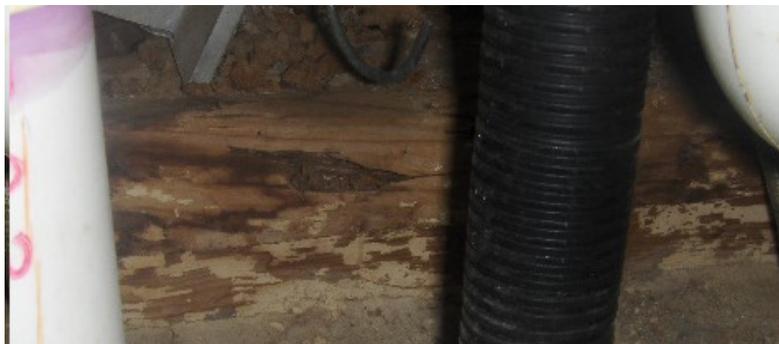
Please note, this is the only visible sill plate in the basement (or the slab section of the house) and this location contains termite damage. There is a very good chance there is other termite damage to the hidden wood framing. Make sure the seller has the property treated for termites and obtains a transferable and renewable guarantee.

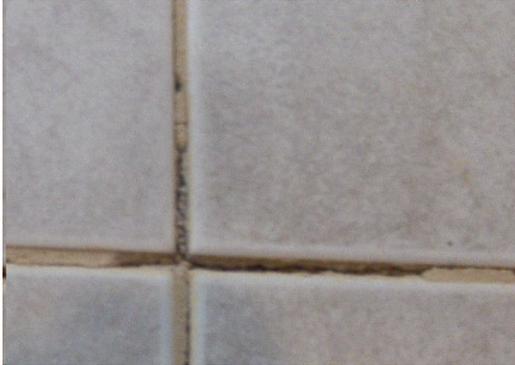
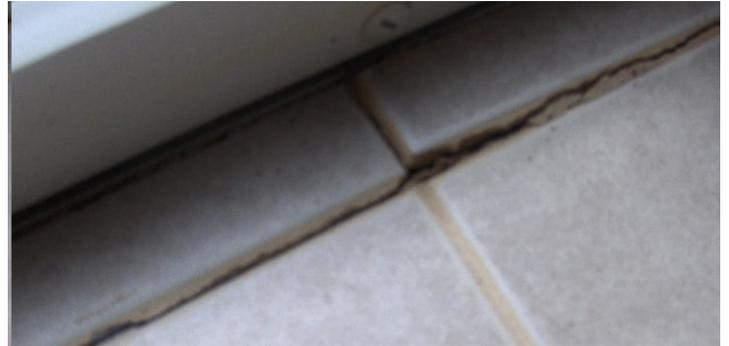
Our examination of the finished areas revealed the bedroom floor located over the garage/kitchen has more than usual flex and the kitchen floor contains damaged tile joints due to movements of the underlying wood structure. The tile floor and extension was reported to be one year old. Make sure you obtain all paperwork for these extension which proves the structure was built to municipal standards. In an attempt to stop further damage to the newly installed kitchen tile floor, install vertical columns in the crawlspace to support the kitchen floor beams at the floor beams mid points.

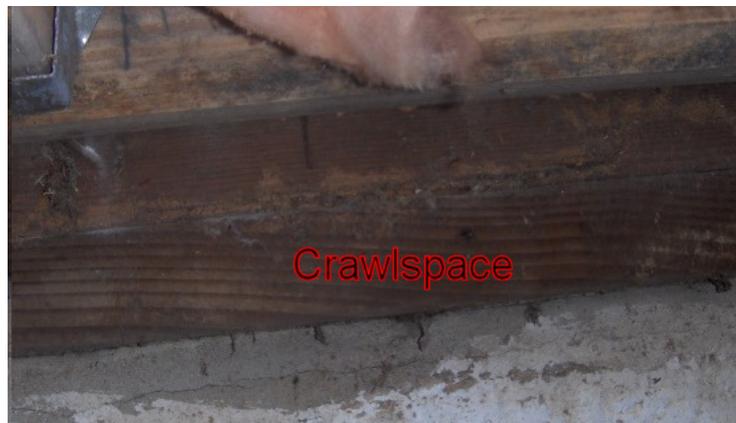
- Termite damage was visible on a basement sill plate.
- A section of the house is built over a slab where the underlying wood framing such as the house sill plate cannot be seen.
- The basement is finished, hiding common termite entry points.
- Superficial termite damage is visible in the crawlspace.

These conditions reveal that termites have hidden access from the soil through slab and foundation cracks to the concealed wood framing. Note, termites can remain active within the walls for years before any evidence of infestation is observable outside the finished walls.

When evidence of termite infestation is found, it is customary for the seller to acquire the termite certificate needed for closing. If the house was recently treated for termite activity, the seller would need to contact the company which issued the service for a termite certificate. If the property was not recently treated, the seller should have the property treated and obtain a renewable and transferable termite contract. You must transfer the contract to your name and pay the termite contract renewal fee each year. Never allow the termite contract to lapse.

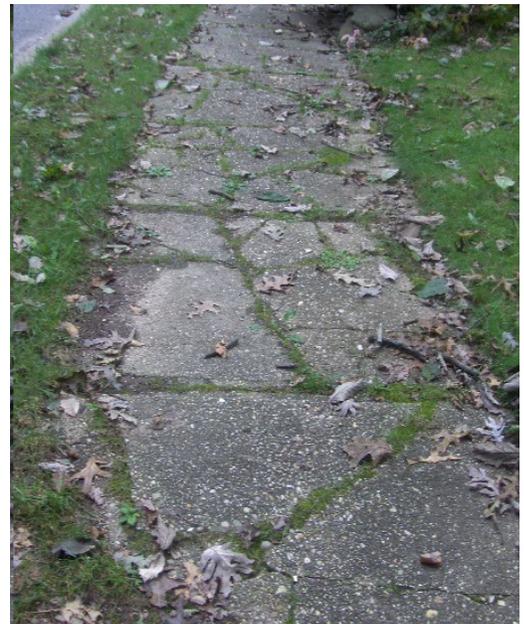
- The sidewalk exhibits approximately 7 flags that are cracked, damaged, contain settled sections and require replacement. If not replaced, rain water seepage and the cold weather freeze/thaw cycle will cause more extensive and serious damage to develop. Anticipated replacement cost is \$2,000.

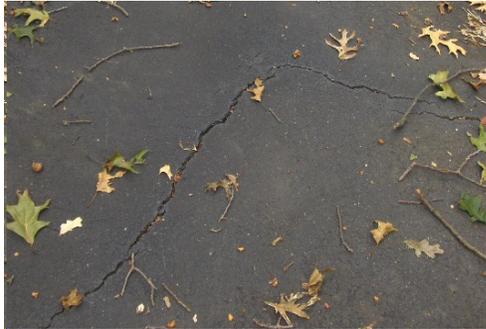
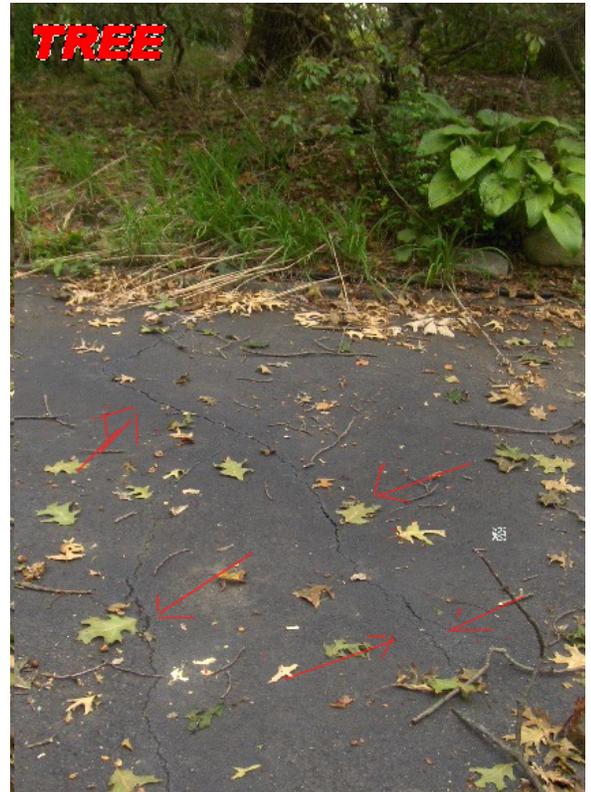
- The seller reported the driveway to be 4 years old. This relatively new driveway contains multiple cracks. We believe the cracks are due to a nearby tree spreading its roots under the driveway. It is recommended that the trees growing near the driveway be removed. Also, the cesspools are located under the driveway. It is strongly recommended that the cesspools be inspected prior to closing for possible damage.

Landscaping. As stated elsewhere in this report, remove trees adjacent to the driveway because they are causing apparent damage to driveway. Ballpark cost estimate is \$3,000.

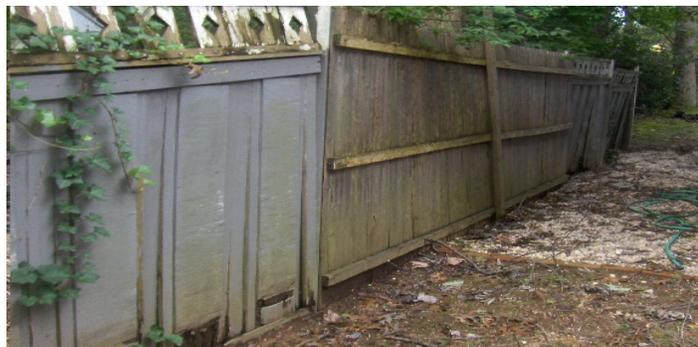
Fences. The wood fence located on the right of the property is old and has sections with rotted support posts, missing pickets and termite damage. We recommend that you replace the fence before injury occurs. Estimated cost is \$2,000.

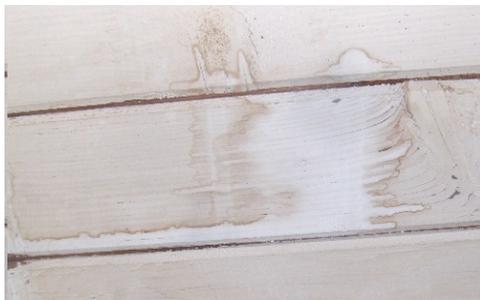
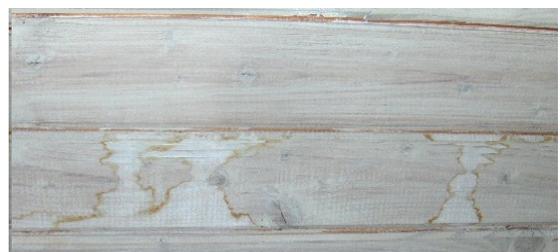
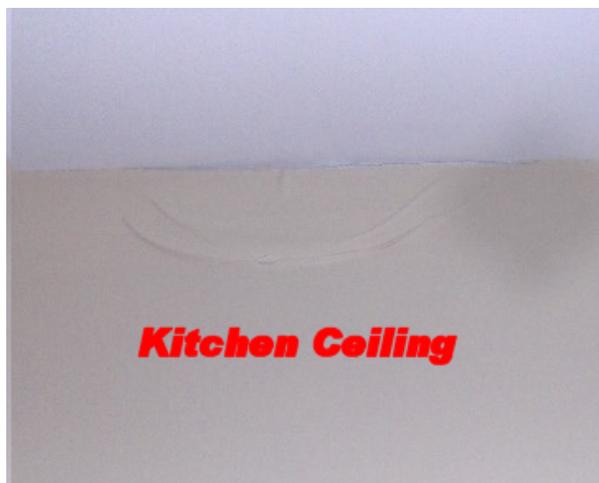
Roof Covering. Our inspection of the main roof covering revealed that it is in good condition however we found ceiling water stains in multiple locations.

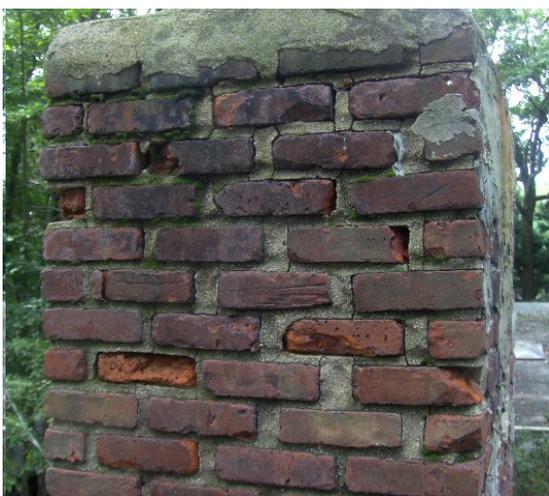
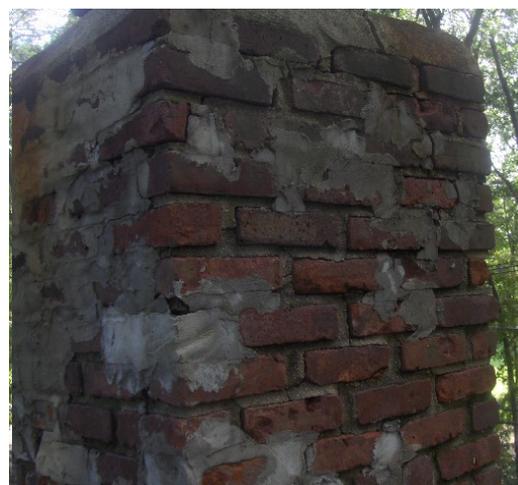
Chimney. Repair several courses of cracked mortar joints and loose bricks near the chimney top. The present condition poses a safety hazard, and if not repaired, will degenerate into more extensive and serious chimney damage during the winter freeze cycle. Estimated immediate cost is \$2,000.

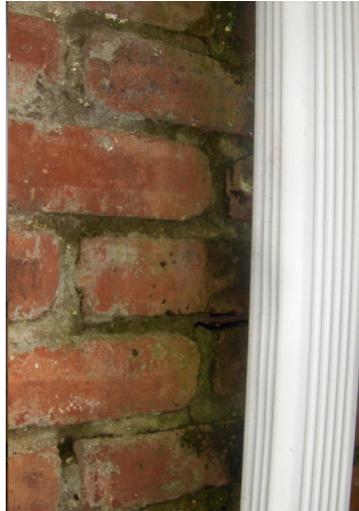
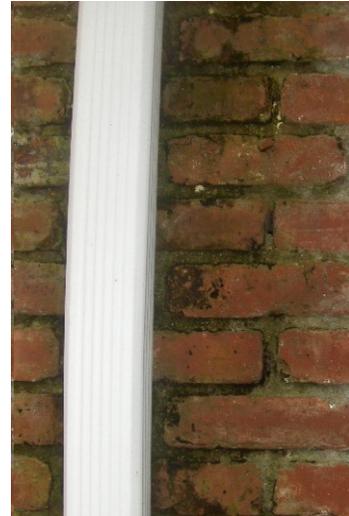
- Repoint the cracked mortar joints between the bricks at the leaders in order to prevent moisture penetration from damaging the underlying structure.

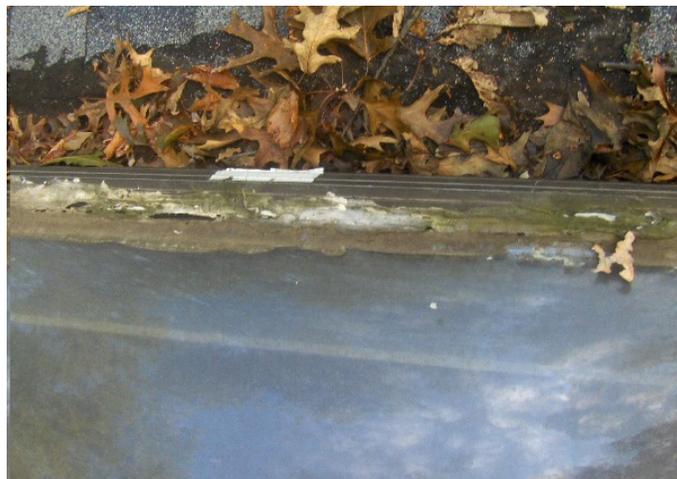
- Restore the dry and crumbling caulking at skylights for weather protection.

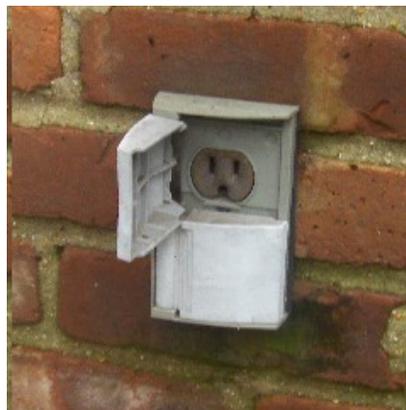
Electrical. Have a licensed electrician replace all exterior standard electrical outlets with GFCI protected electrical outlets. Cost estimates will be included in the Electrical section of this report.

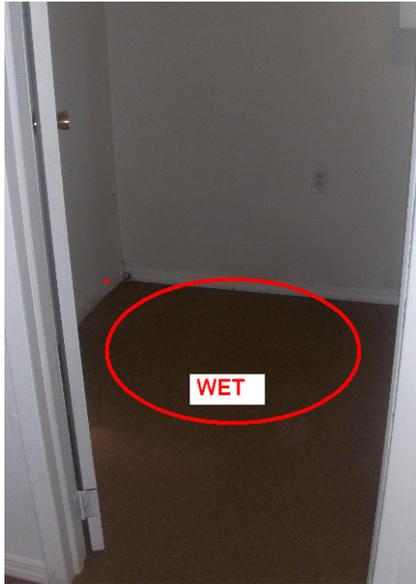
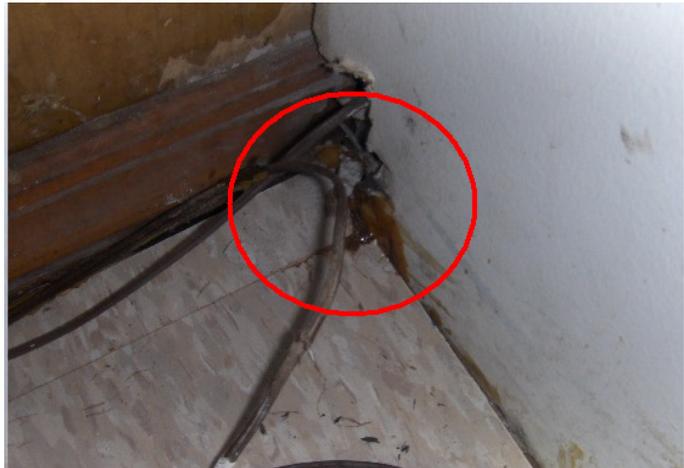
Foundation Water Leaks. Our inspection of the basement walls and floor revealed characteristic evidence of recurrent foundation water leaks. These include moisture on a basement rugged room and water on the floor of boiler room.

Based on our observations, we suspect that the leakage is the result of:

- Air Conditioner compressor installed too close to the structure;
- Foundation settlement cracks behind the finished walls;
- Chimney damaged joints causing water to leak down to tee basement;
- Condensation from the air conditioner unit
- Overflowing gutters and leaders which allow rain water to pond next to the foundation wall;
- A high ground water elevation which causes water to penetrate through the floor.

- Regrade any low areas adjacent to the foundation, at a positive slope of ½ inch per linear foot for a distance of six feet away from the house;
- Clean gutters and ensure the gutters and leaders never overflow and the leader ells discharge water at least three feet from the foundation;
- Repair Chimney.
- Move Air compressor away from the house;
- Open wall and patch any foundation cracks with hydraulic cement;

After making these improvements, you must then observe the basement over a period of several months in order to determine if additional repairs are required. This is particularly important because the extent of foundation cracks and leaks could be hidden behind the wall panels in the finished areas.

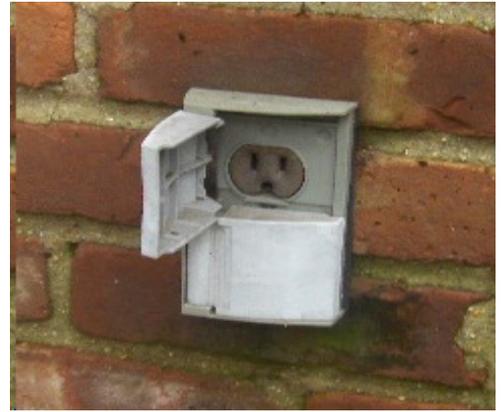
- Ground Fault Circuit Interrupter (GFCI) protection was found in the kitchen, garage and bathrooms and some exterior locations. We recommend you install GFCI in all wet areas including the rear exterior wall and near the bar sink.

A licensed electrician must make these immediate miscellaneous repairs. Estimated cost: \$500.

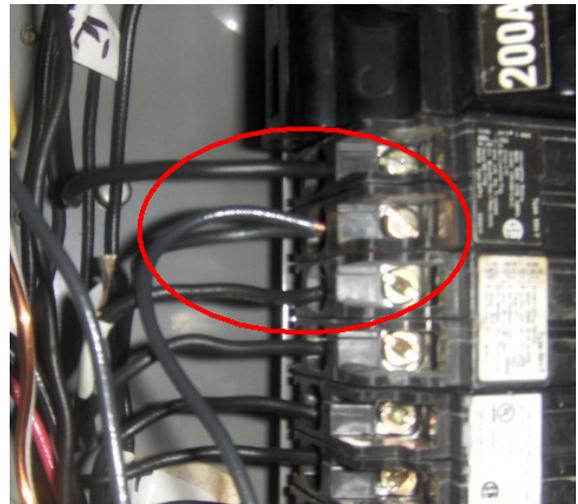
- There is a double tapped circuit breaker installed in the main panel box. This must be corrected. Only one circuit can be connected to a circuit breaker.

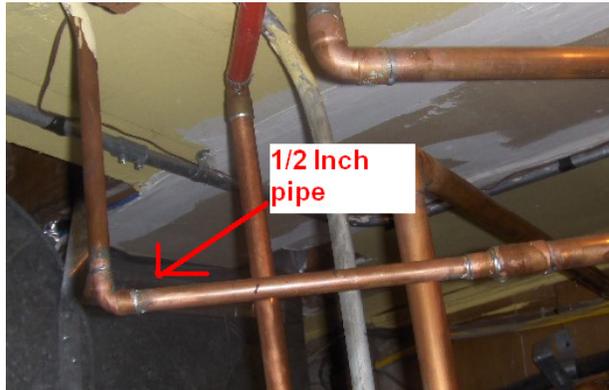
- Active leaks was found under the hallway bathroom's vanity sink.
- The water to the refrigerator was not operational.
- The use of a ½ inch pipe in the main hot water supply pipe will cause the hot water flow rate to be low during periods of high demand. This defect will be corrected when a new hot water tank is installed.

The seller must have a licensed plumber survey the entire premise and repair all plumbing leaks.

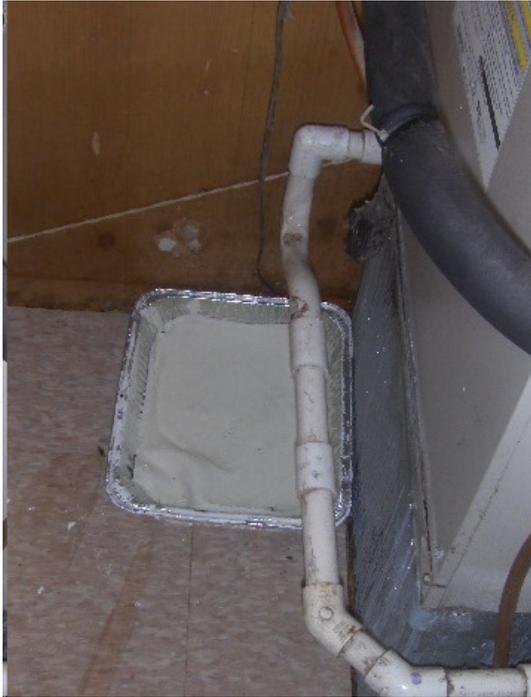
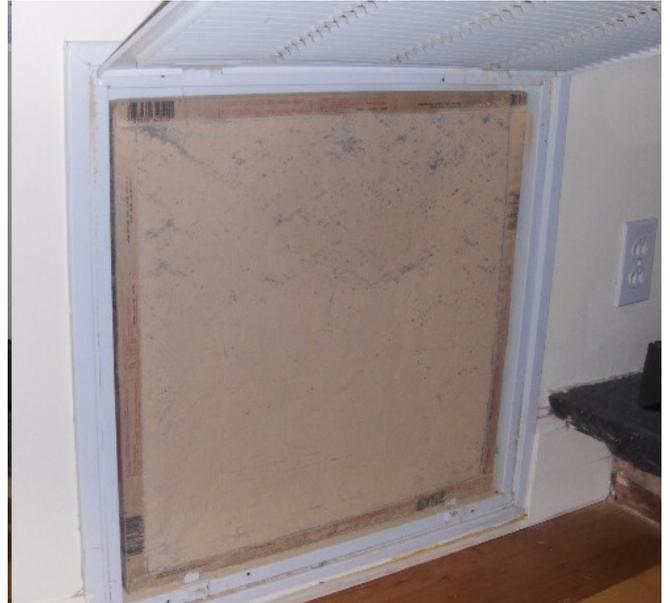
- The air conditioner located on the ground level did not operate. The seller must have this air conditioner operating prior to closing.
- The handler located in the basement is leaking. The seller must have this corrected prior to closing.
- Three of the compressors are reaching their serviceable life. Anticipate replacement cost is \$4,000 each.
- The filters were filled with dirt which may have caused damaged to the systems.

Prior to closing, the seller must have an air conditioner expert survey all units and provide required repairs and service.
