PREMISES DESCRIPTION

Prelude. This house has not been properly maintained over the decades and requires expensive renovations to major systems. With this type of inspection we can only concentrate on gross defects with the major systems. It is our opinion this house is not habitable. Here is a list of certain corrections that are required just to make this house somewhat liveable. You must read the entire report.

Findings and Recommendations

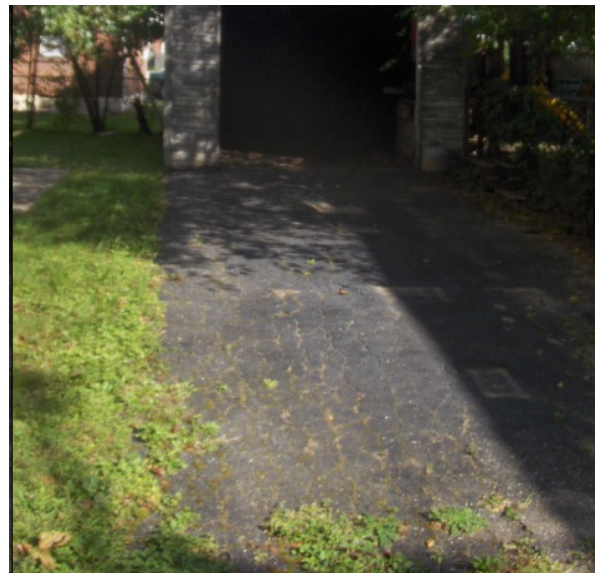
- The driveway has not been maintained and exhibits cracked, damaged and settled sections and requires replacement. If not replaced, rain water seepage and the cold weather freeze/thaw cycle will cause more extensive and serious damage to develop. Anticipated replacement cost is \$5,000.

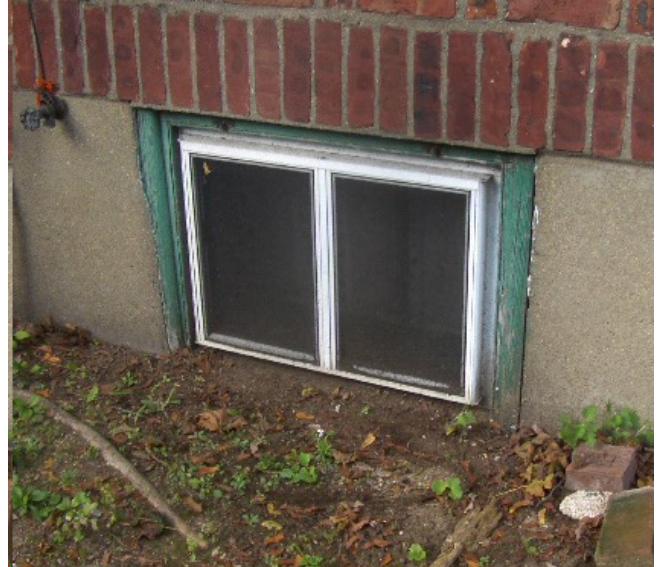
- Improper grading is the most frequent cause of foundation water penetration. Our inspection found that the ground adjacent to sections of the foundation walls are back sloped and eroded. This condition allows water to accumulate at the foundation which has produced basement water leakage and dampness. These low areas must be regraded at a positive slope of 1" per linear foot for a distance of six feet away from the house to direct surface water away from the foundation. Before grading, install window wells and make sure the dirt is at least six inches below the level of the window sill.

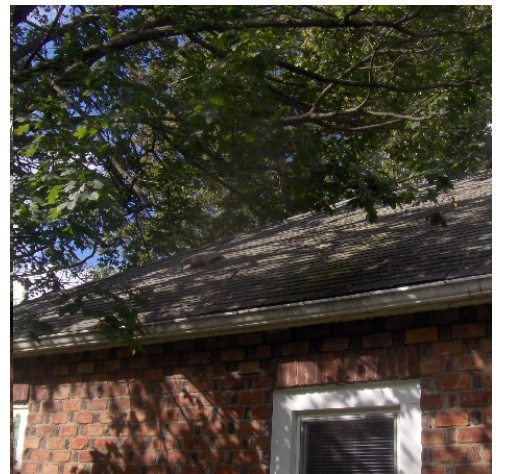
- Trim tree branches which are over the house because they will cause damage and give rodents access to the attic via the roof. Vegetation must always be trimmed to provide clearance from the building

Estimated cost is \$1,500.

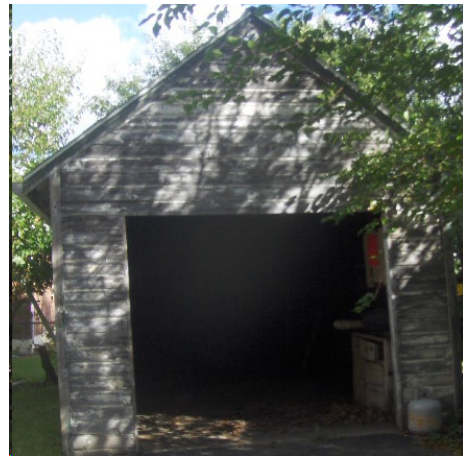
Our survey of the garage revealed that it is structurally damaged, crooked and leaning to the left. In an attempt to salvage the garage, we recommend the following corrections before the garage collapses and/or causes injury. It is believed that the condition of the garage may impact obtaining a FHA mortgage. Below is a survey

- The right wall of the garage is termite damaged and requires replacement.
- The garage does not have a masonry foundation which allows the sill plate to make ground contact. A concrete footing must be installed under the wood framing.
- The garage door is very old and requires replacement.
- The exterior siding would be better served by installing vinyl siding.

Ballpark estimate to rehabilitate this garage is \$6,000.

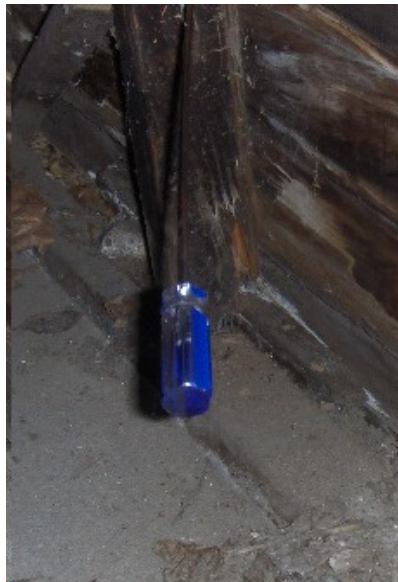
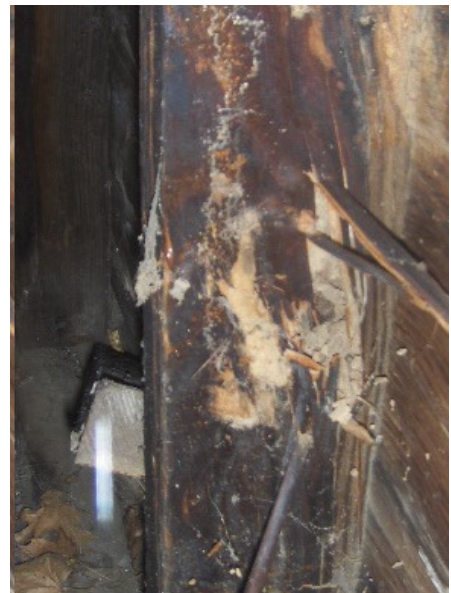
- Photos shows:
- Termite damage garage wall
 - Studs are off the sill plate
 - Sill plate making dirt contact

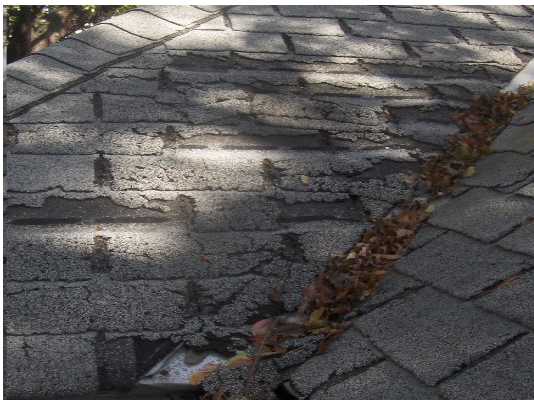
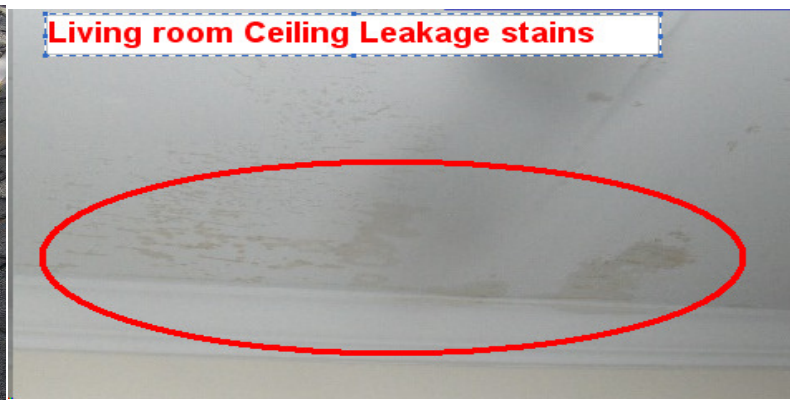
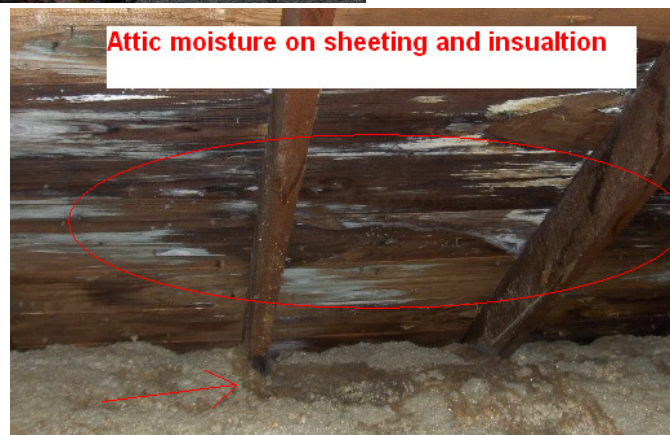
Roof Covering. Our inspection of the main roof covering revealed that it is in poor condition and should have been replaced years ago. It exhibited an overall loss of mineral granules and many of its shingles are curled, cracked and damaged.

Also, our inspection of the interior room ceilings and attic confirms the house needs to be re-roofed because leakage stains and moisture were present. Estimated cost to replace roof shingles, gutters and possible underlying sheathing damage is \$6,500.

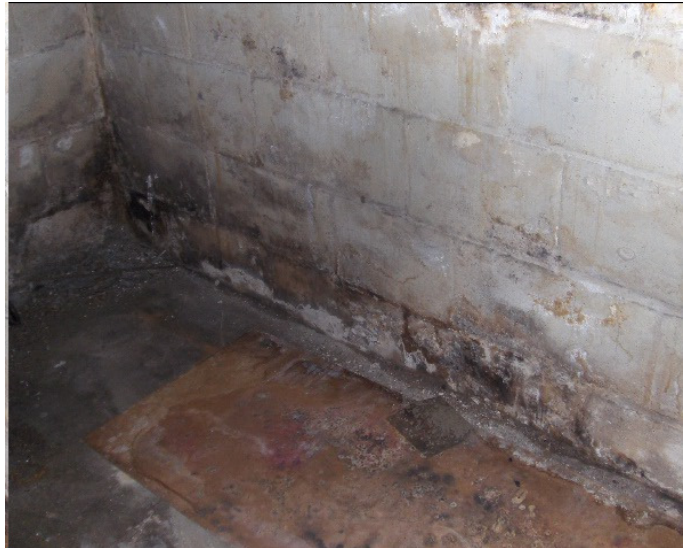
Foundation Water Leaks. Our inspection of the basement walls and floor revealed characteristic evidence of recurrent foundation water leaks. These include:

- Moisture on the walls and floor;
- Mold and mildew stains,
- A damp odor.

Based on our observations, we suspect that the leakage is the result of:

- The house is built on a masonry block foundation which is vulnerable to leakage. The walls are quite porous and more often than not indicate some degree of seepage. When the hydrostatic pressure on the exterior portion of the wall is high, the voids within the blocks often fill with water that results in leakage.
- Poor site grading which allows water to pond next to the foundation wall;
- Foundation settlement cracks;
- Missing basement window wells;
- Damaged and overflowing gutters and leaders which allow rain water to pond next to the foundation wall;
- Leaders which discharge water next to the foundation wall;

Before you undertake any costly water leakage control measures, such as exterior waterproofing or an interior sub-slab drainage system, you must first perform the following maintenance:

- Regrade any low areas adjacent to the foundation, at a positive slope of ½ inch per linear foot for a distance of six feet away from the house;
- Install new gutters and ensure the gutters and leaders never overflow and the leader ells discharge water at least three feet from the foundation;
- Install window well;
- Patch all foundation cracks with hydraulic cement and coat the entire basement walls with a masonry waterproofing such as Drylok.

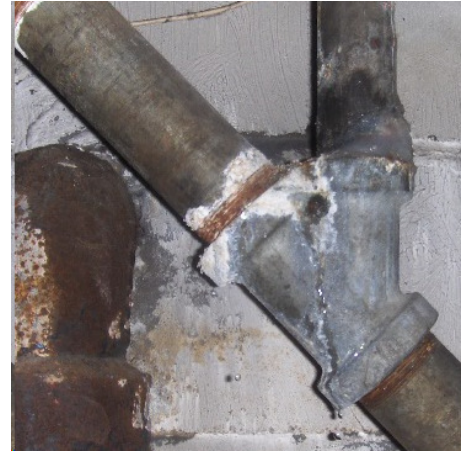
- The plumbing system visible in the basement is leaking in multiple locations due to cracks in the old drain pipes. Also, the toilet was not operating. Estimated cost repair toilet and to replace all metal waste drain pipes with PVC is \$2,000

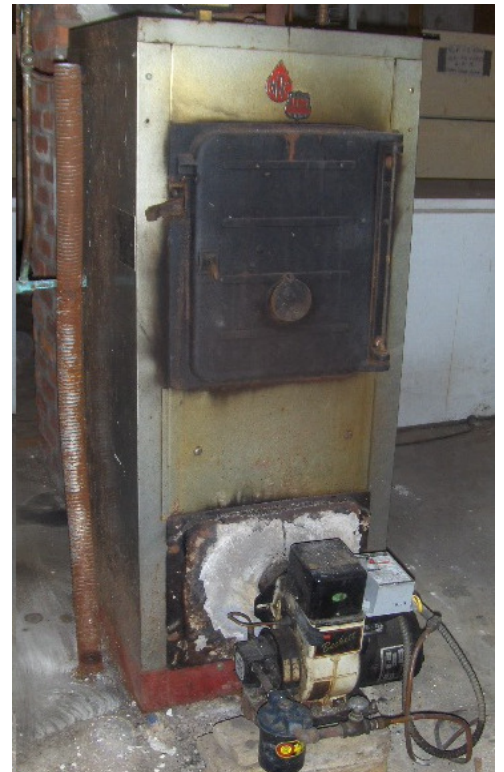
Operating Condition. The heating system was not activated because the system was turned off by the Realtor and it common knowledge that the boiler is well beyond it serviceable life and requires replacement. Estimated cost is \$6,000

Since the street is supplied with gas, it is suggested that a gas fired burner be installed. This will eliminate the need for oil fuel deliveries and you can abandon the buried oil tank.

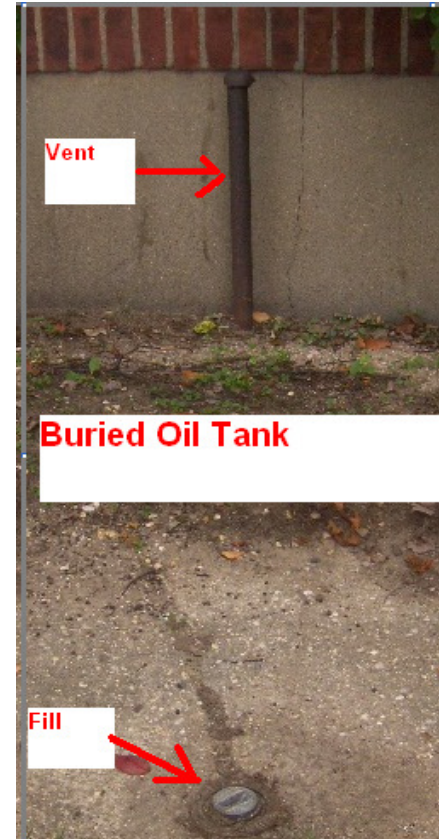
Under Ground Oil-Storage Tanks. Our inspection revealed that heating fuel oil is stored in an underground tank located on the property. If the tank or its buried fuel line spring a leak, or if oil seeps into the groundwater, the homeowner is liable for removing the tank, excavating the contaminated soil and for the costly cleaning of the contaminated groundwater. Before closing title, have the tank tested and certified that it is free of leaks. After taking possession of the premises, deactivate the buried oil tank. Estimated immediate cost: \$2,000.

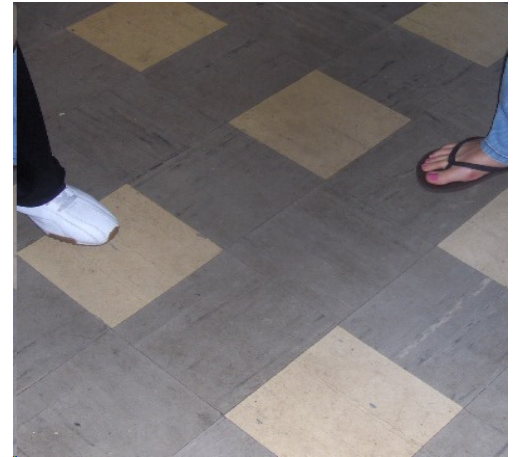
Kitchen. The kitchen floor appears to have 9"x9" vinyl/asbestos floor tiles. A sample of the floor tile should be tested. Asbestos Asbestos tiles can only be legally and safely removed by a specialist. Or you can encapsulated these tiles by another floor covering.

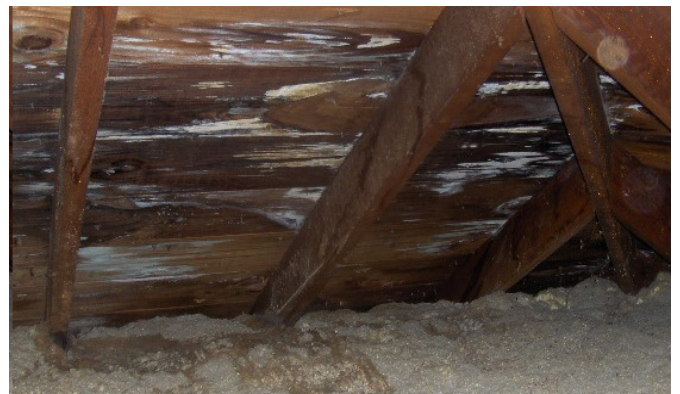
Water Penetration. We observed evidence of active water penetration on the roof structure. This will be repaired when the roof is replaced. Sections of water damaged sheeting may need to be replaced with the new roof shingles.
